Kaysville City Facilities Master Plan

April 2016

Master Plan Summary and Process

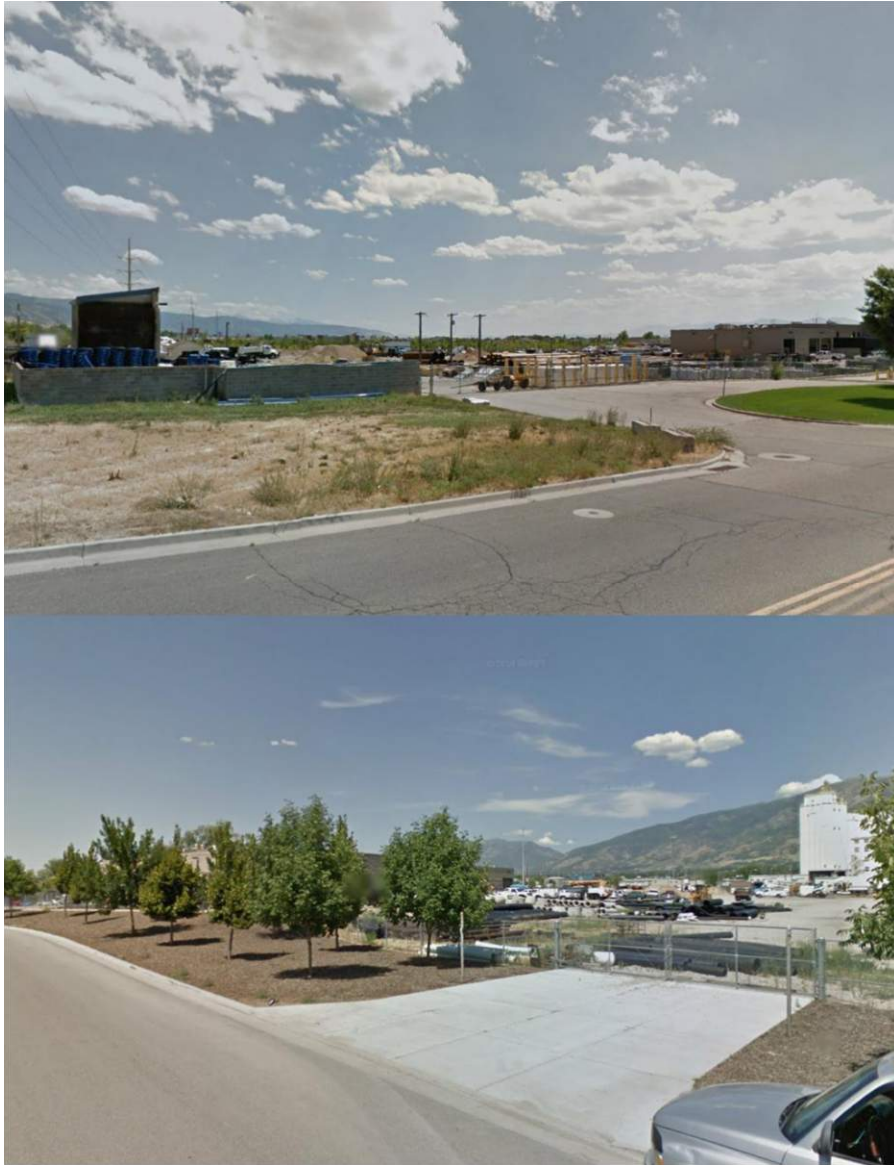
Operations Center Site

- Current useable area is approximately 247,541 sf. or 5.68 acres
- Overall site includes 208,217 sf. or 4.78 acres to South that will be vacated by current lease
- Site use includes the following:
 - ☐ Operations Center
 - ☐ Fuel island for Fleet use (Not covered)
 - ☐ Material and yard storage for Power, Public Works and Parks & Recreation
 - ☐ Vehicle storage for all departments
 - ☐ Public and employee parking

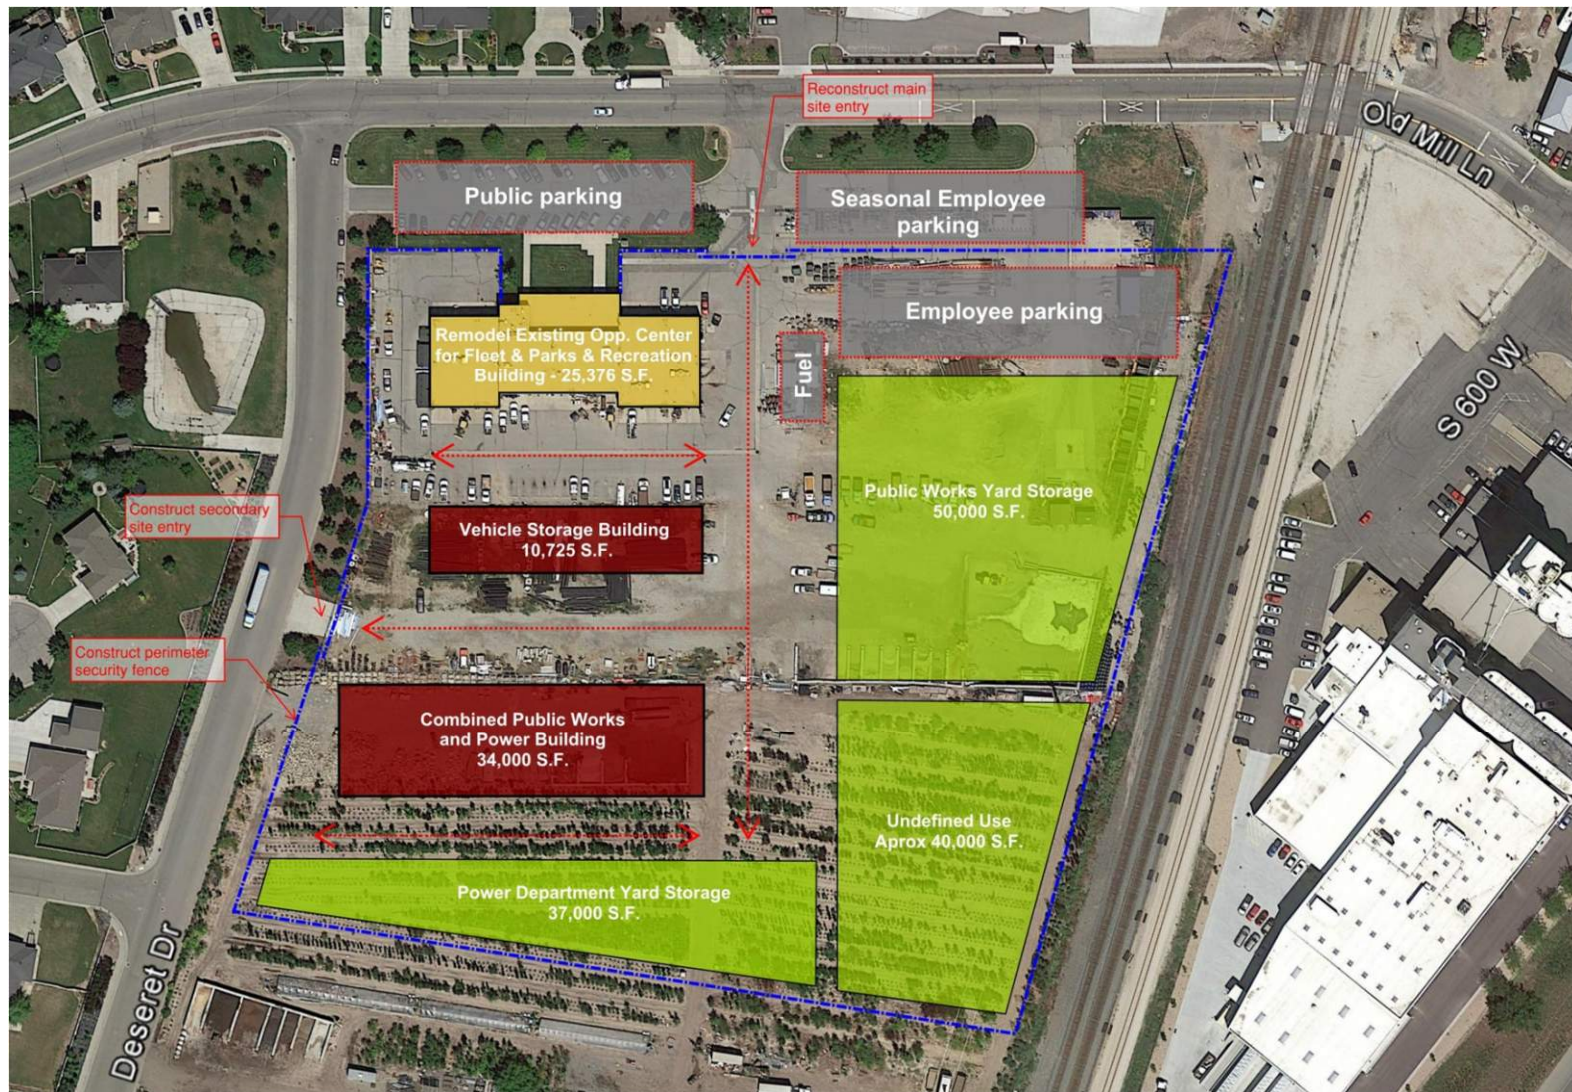
Proposed Operations Center Site

- Remainder of Site work - \$750,000
- 540 sf. covered vehicle storage - \$24,300
- 6,000 sf. salt storage bin - \$330,000
- 3,150 sf. of material storage bins - \$204,750
- 13 sander racks @ \$16,500 each = \$214,500
